Manhole Inspection Summary

Manhole # S65O__011MH

Location Address: **6202 Boston St.**

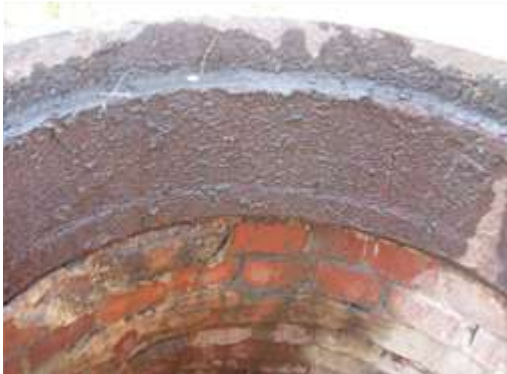
Defect 2

Infiltration: ☐ None ☒ **Joint** ☐ Cracks ☒ **Mortar** ☐ Roots ☐ Wall

infiltration

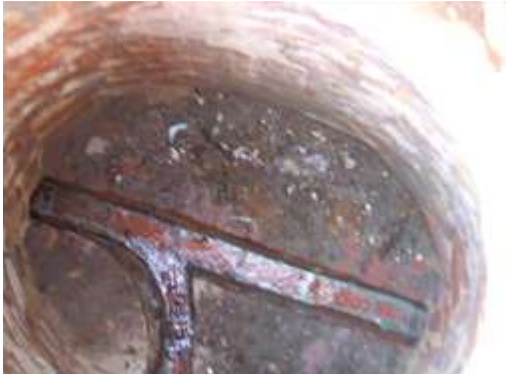
Defect 3

Condition: ☐ Sound ☐ Cracked ☐ Root Intrusion ☐ Deteriorated ☐ Leaks ☒ **Debris**

debris

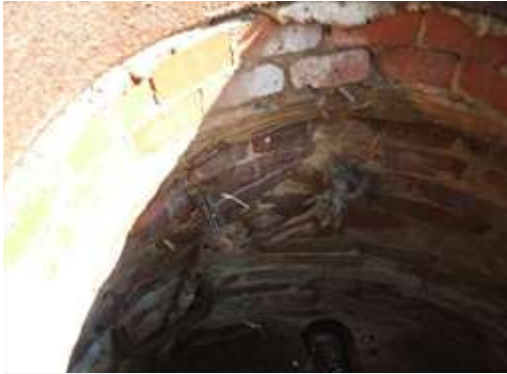
Defect 1

Condition: ☐ Sound ☐ Cracked ☐ Root Intrusion ☒ **Loose Brick** ☒ **Deteriorated**

loose bricks

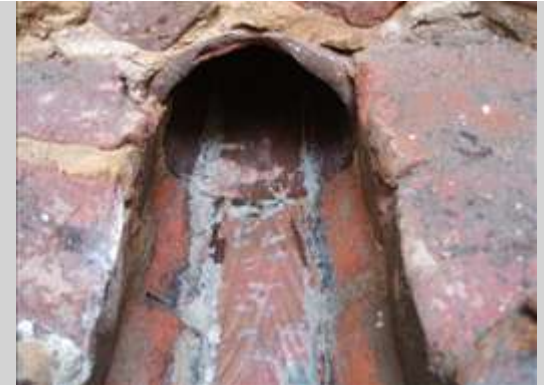
12 O'Clock Outflow

6 in. Circular Gravity Sewer
Pipe Out @ 12 O'Clock

Invert Depth: **5.80** (ft.) Flow Characteristics: **Slow**

Infiltration: **None** Pipe Seal Cond: **Sound**

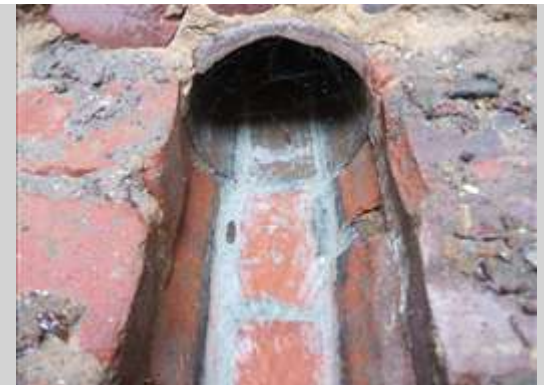
6 O'Clock Inflow

6 in. Circular Gravity Sewer
Pipe In @ 6 O'Clock

Invert Depth: **5.70** (ft.) Flow Characteristics: **Slow**

Infiltration: Pipe Seal Cond: **Sound**

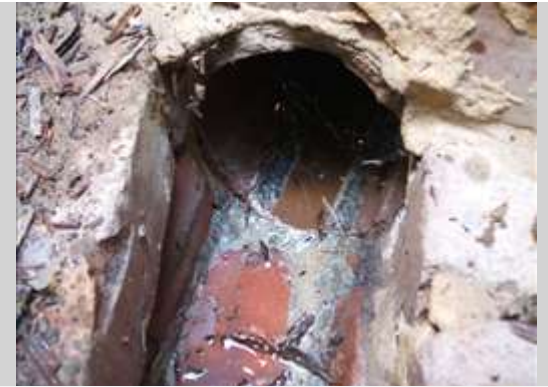
9 O'Clock Inflow

6 in. Circular Gravity Sewer

Pipe In @ 9 O'Clock

Invert Depth: **5.70** (ft.) Flow Characteristics: **Slow**

Infiltration: **None** Pipe Seal Cond: **Sound**

Connects To: **Dead End**
